OUTLINE OF REPAIRS

OUTLINE OF REPAIRSTABLE OF CONTENT

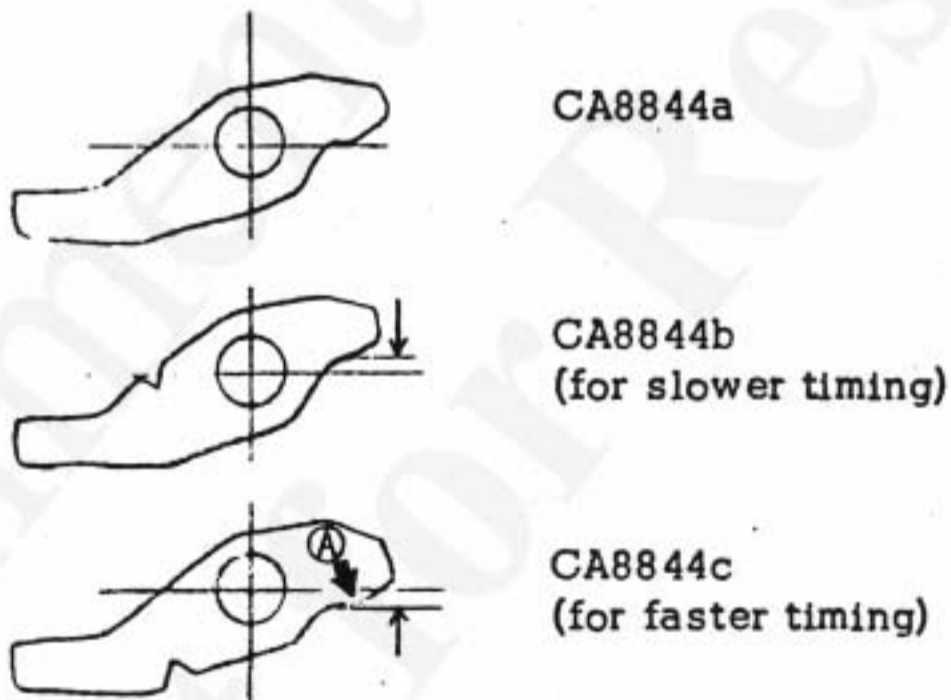
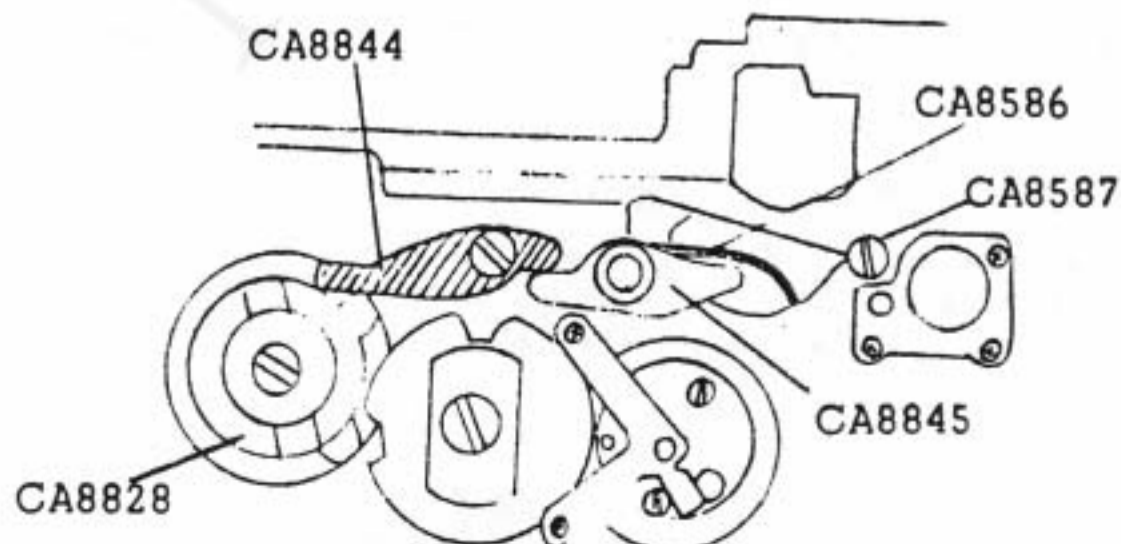
1) Improper selection of CA8844 (Lever)

8844 is available in following 3 types. Adjustment should be made on the timing of brake release by replacement of 8844 with a proper type.

Some of 8844 are bent for adjustment of engagement between 8828 (Shaft) and 8833 (Plate). This should be checked at the time of replacement.

If, even upon replacement with 8844C, the film advance motion is not smooth yet, the portion marked A may be slightly hammered out. (Do not work excessively, as it will cause the spring to be readily pressed from the beginning of the motion.)

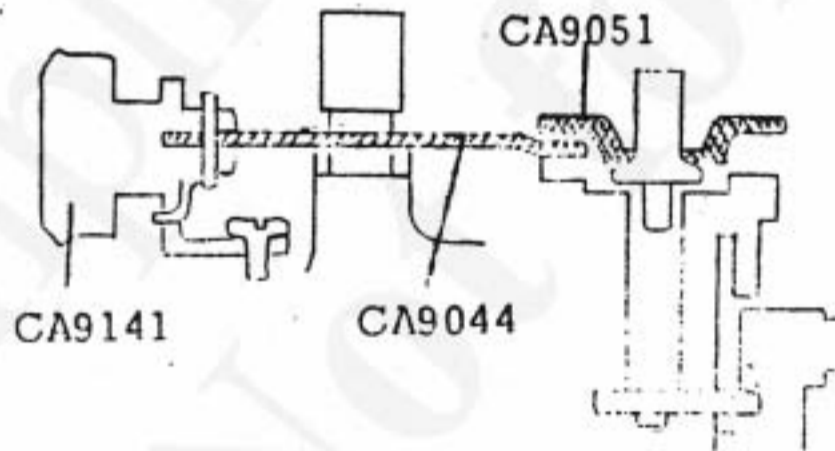
2) CA9051 (Plate) stuck with CA9044 (Plate)

When 9051 is extremely deformed, replacement is required. Clean the sliding portion of both 9051 and 9044, and apply small amount of Molicote (Grease) Type U.

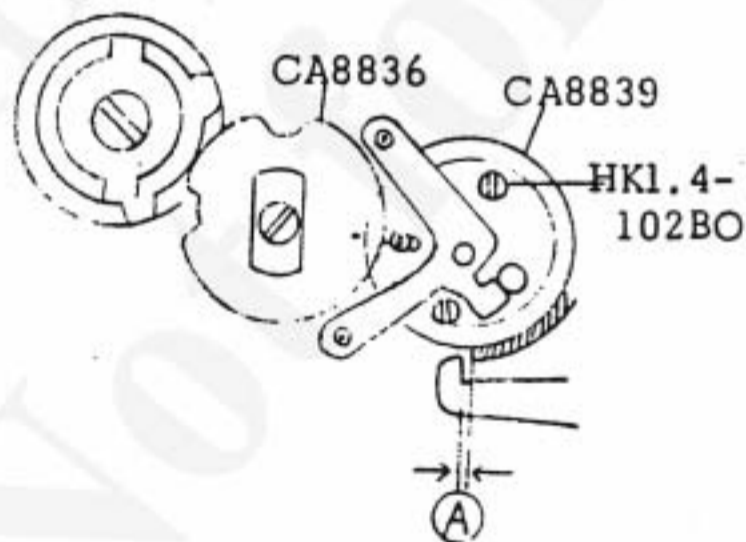
- (2) If insufficient engagement is found in the vertical direction,
- o Bend 8592 and adjust
 - o Adjust tolerance on 8592
 - o Replace 8592
 - o Replace the Gear A (the whole assembly of 8543)
4. Excessive or insufficient film advancement for Shutter-Charging
- 1) Improper adjustment of Eccentric Screw (8809)

In case of insufficient film advancement, loosen two HK1.4-102BO to widen the distance at A by adjusting (8809).

In case of excessive film advancement, narrow the distance at A by adjustment of (8809).

Care must be taken not to make an over adjustment causing the mechanism unchargeable.

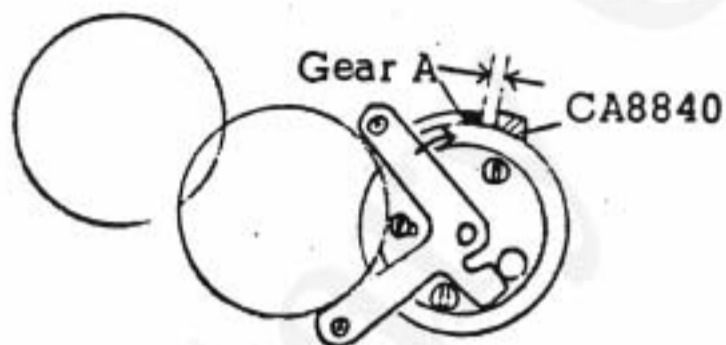
Prior to film advancement, when the Gear A is pressed in the arrowed direction, the distance between 8840 and the Gear A should be $-0.10 \sim +0.3$. (-0.10 means the state where the Gear A comes in contact with 8840 and further moves by 0.1.)

Adjustment is similarly made by (8809).

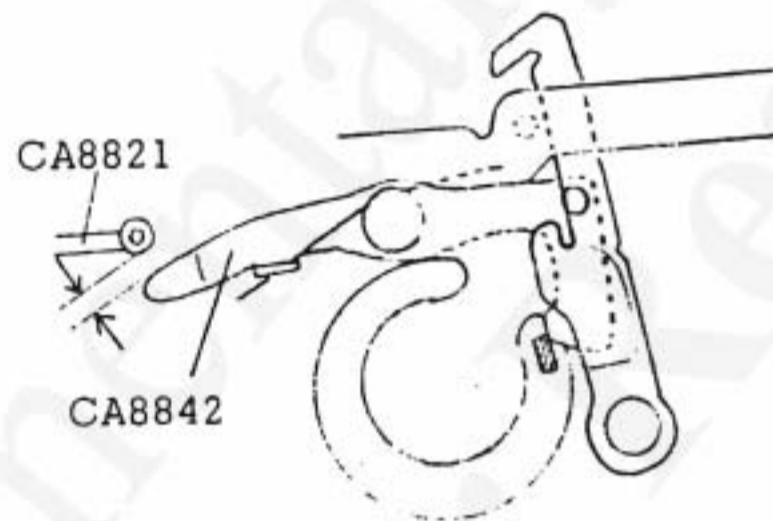
- (1) If the shutter cannot be released upon film advancement, check if 8842 (Lever) and the Stopper Ring of 8821 (Lever) are in contact with each other. They should not.

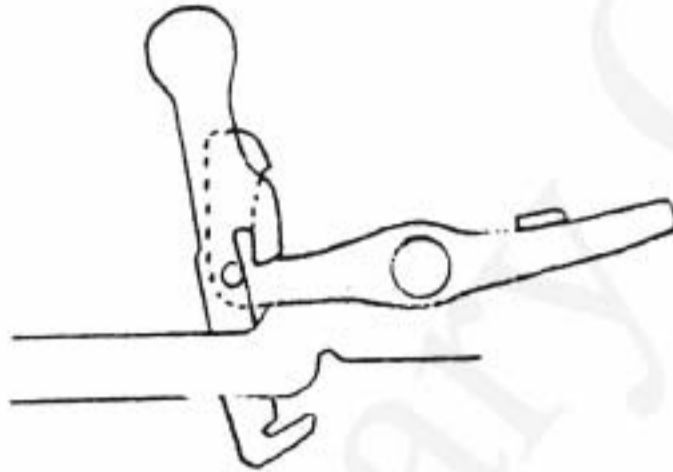
6. The shutter can be released during or prior to film advancement.

Check the operation of related parts. If the shutter cannot be released even upon film advancement, make sure 8850 (Pin) is not hitting 8810 (Plate).

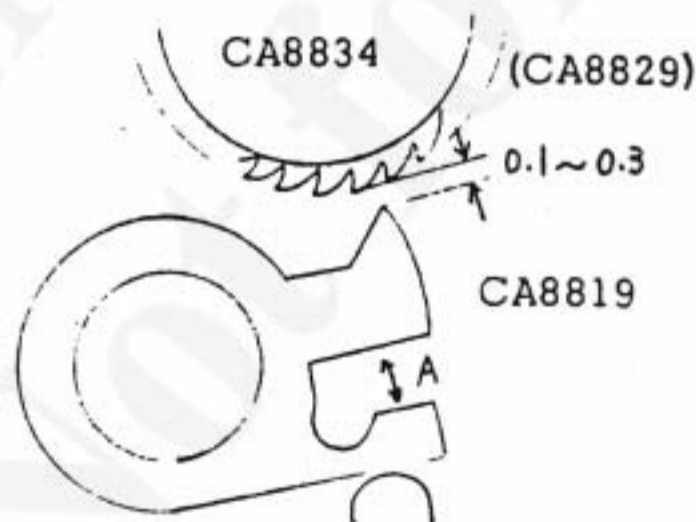
- 1) Improper operation and/or adjustment of CA8819 (Claw)

Refer to the checkup column. Adjust the distance A on 8819.

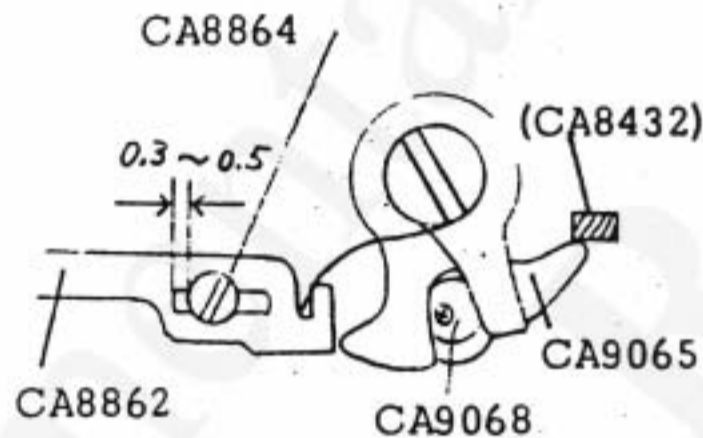
10. The shutter releasing position of the button too deep or too shallow. Excessive or insufficient leeway in the button motion after the shutter release.

1) Improper adjustment of CA9068 (Collar).

9068 should be adjusted so that the mirror commences its operation when the distance between the oblong hole of 8862 and 8864 at their edges is $0.3 \sim 0.5$.

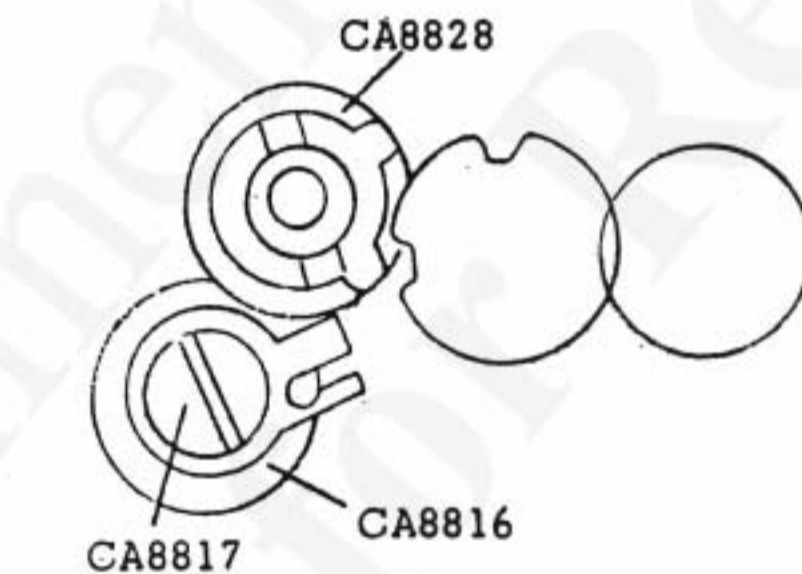
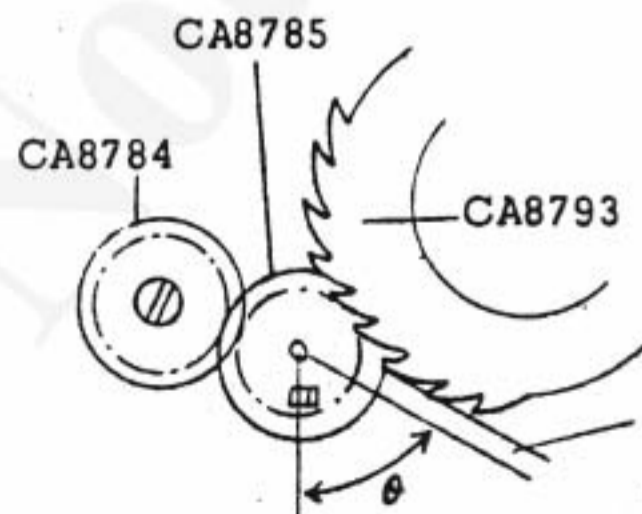
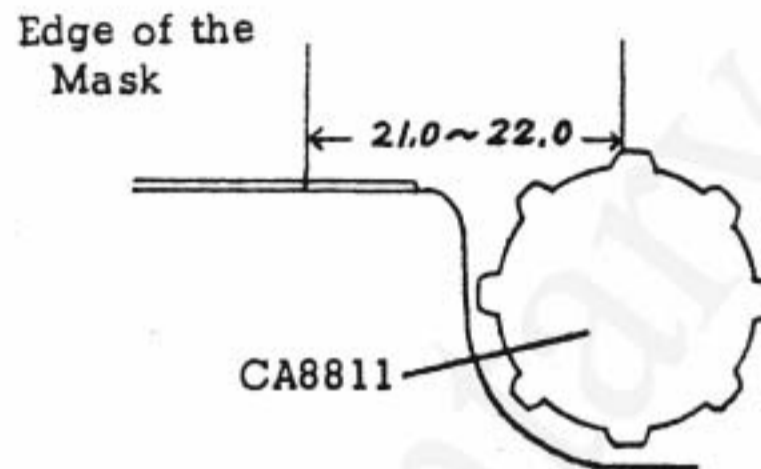
12. Uneven intervals between picture frames.

1) Improper positioning of Sprocket Teeth

After the film is advanced and locked, bring 8785 (Gear) to rise within the range θ , and make following adjustments:

Loosen 8817 (Screw) and change the position of engagement between 8816 (Gear) and 8834 (Gear).

The Sprocket will turn 1.66mm more, or less, when the engagement is changed by a tooth on 8816 (Gear). → (The lowest gear is 8834.)

The space between 8793 and 8785 should be 1mm or above.
 The clearance between boss of 8785 and 8793 should be over than 1mm.

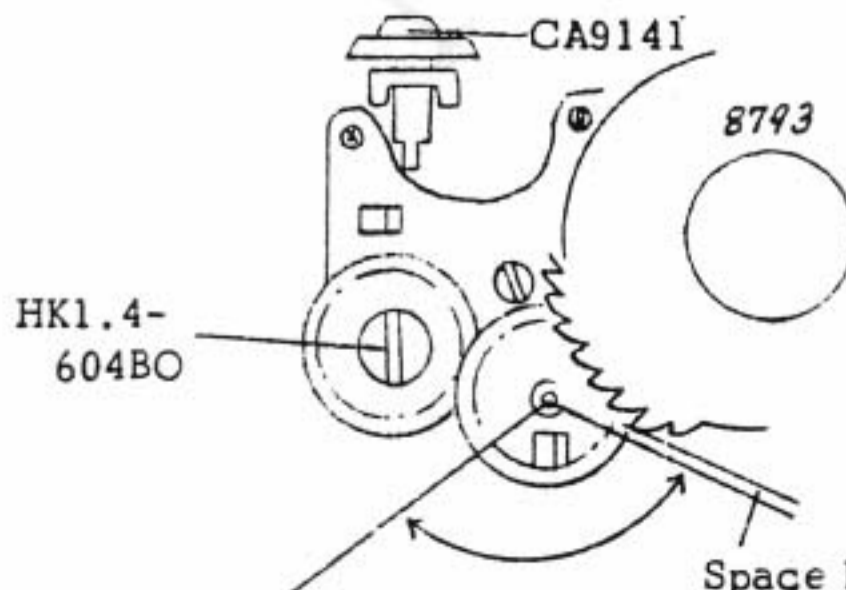
13. Film Counter Plate not moving properly.

1) Improper positioning of CA8785 (Gear).

Set 9141 and loosen HK7.4-604 BO on 8784 to let it rise and adjust 8785 position. Upon completion of film advancement, 8785 should be positioned as follows (within the range shown by arrows.)

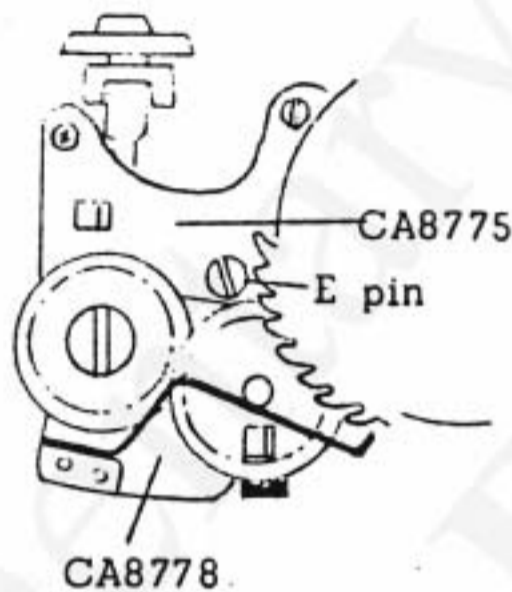
2) Improper positioning of CA8778 (Lever)

Keeping the E pin of 8775 at the neutral position of its eccentric motion, bend the Plate (A) so that 8778 will hit the E pin when the Rear Cover is closed.

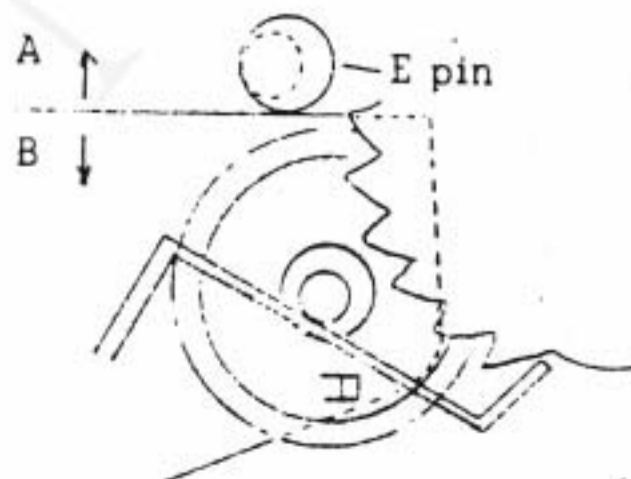
4) Improper position of CA8790 (Stopper)

When the Rear Cover is closed, the tip of (8790) should hit the bottom of the teeth of (8793). If it does not, an adjustment should be made by bending (8790) at the S position. Some room may be permissible between (8787) and (8790).

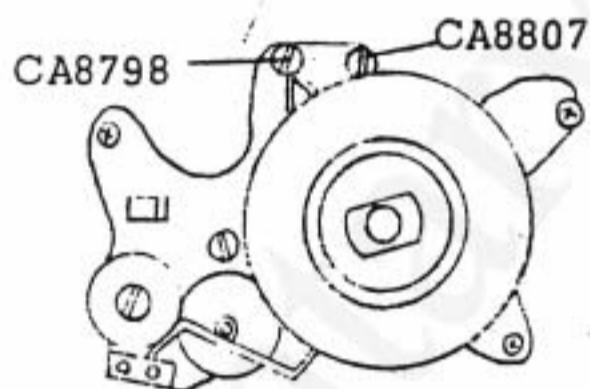
14. S point of the Film Counter Plate out of position.

Loosen 8798 and adjust eccentricity of 8807 so that the tip of (8790) touches the bottom of the first tooth of 8793.

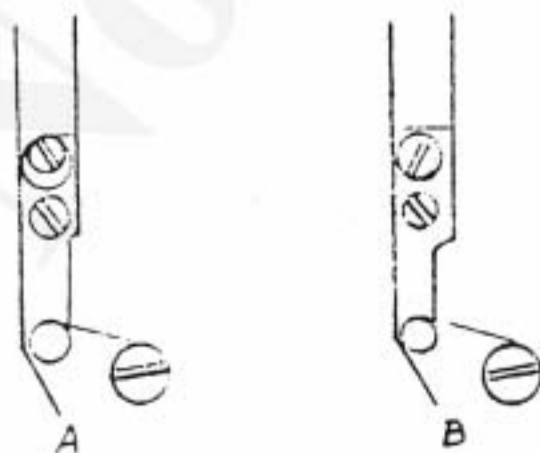
15. Little leeway stroke after the shutter release by the self-timer.

A : Bigger leeway stroke after the shutter release and shorter self-timer operation.

B : Little stroke after the shutter release and longer self-timer operation.

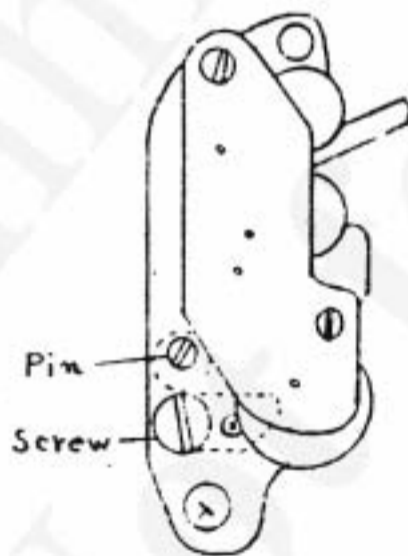
16. ST lever not pointing straight up.

1) S stopper pin of the self-timer not properly adjusted.

Loosen the screw and adjust the S stopper pin (eccentric). After adjustment, tighten the screw fully and bond it with Aron Alpha.

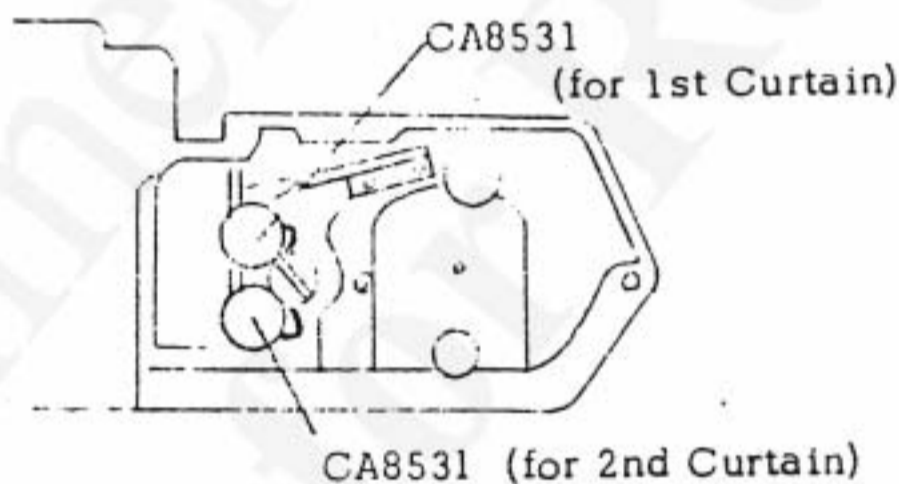
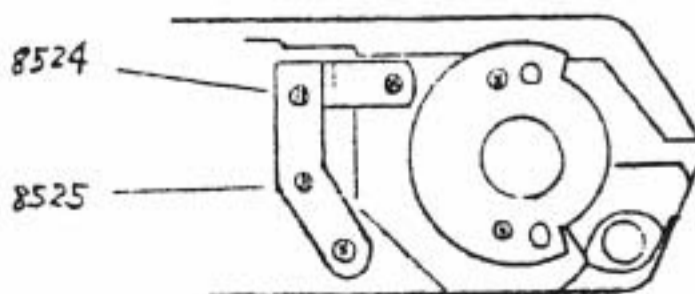
1. Excessive or insufficient speed of the curtains.

1) Improper adjustment of CA8531 (Nut)

The curtain speed is adjusted by 8531. Refer to the checkup column and make adjustment.

Turn 8531 to the right to weaken the curtain tension and thus slow down the speed.

Turn 8531 to the left to increase the tension and thus speed up the curtain run.

Adjustments may be made by 8525 (Shaft) and 8524 (Shaft). Turn them to the right for stronger tension and faster speed, and to the left for weaker tension and slower speed. Care must be taken not to deform the driver groove at the upper end of 8525 and 8524, as it will cause poor operation of the curtains.

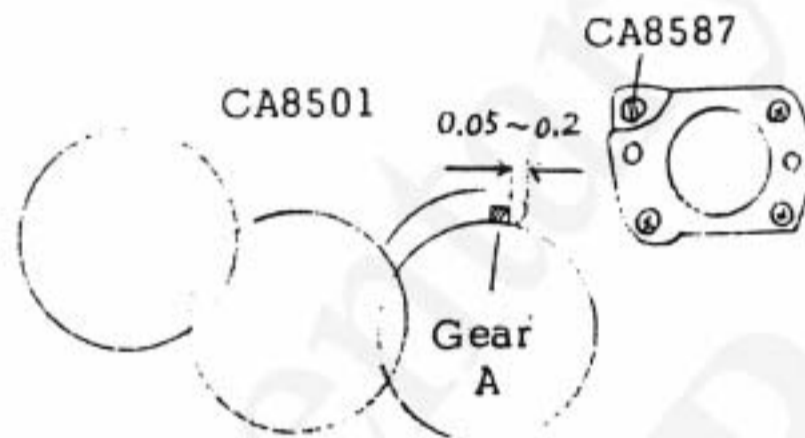
3) Brake adjustment unsatisfactory.

Upon adjustment of the curtain speed, when the shutter is released at 1/1000 or B, there should be a room of 0.05 - 0.2mm between 8501 (Base Plate) and the Gear A. If not, it should be adjusted to be within that range by 8587 (Screw). (It will change the spring tension of 8586 (Spring).)

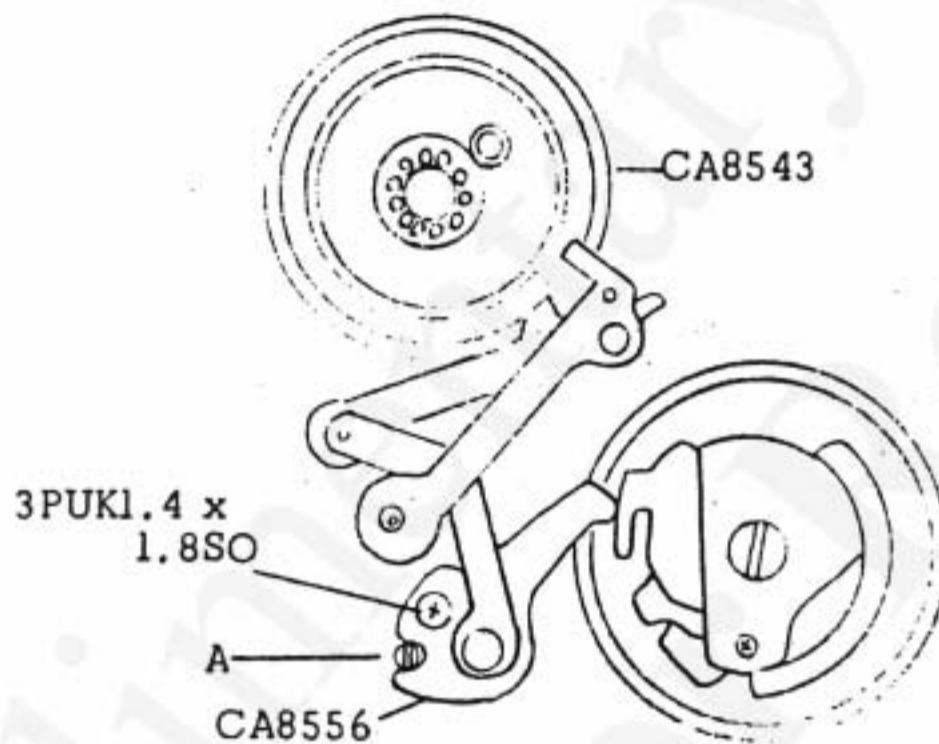
5. Improper timing at high shutter speeds:

If the speed at 1/1000 - 1/60 sec. is in average longer (or shorter) than the proper timing, and adjustment is to be made with A of 8556 (Lever).

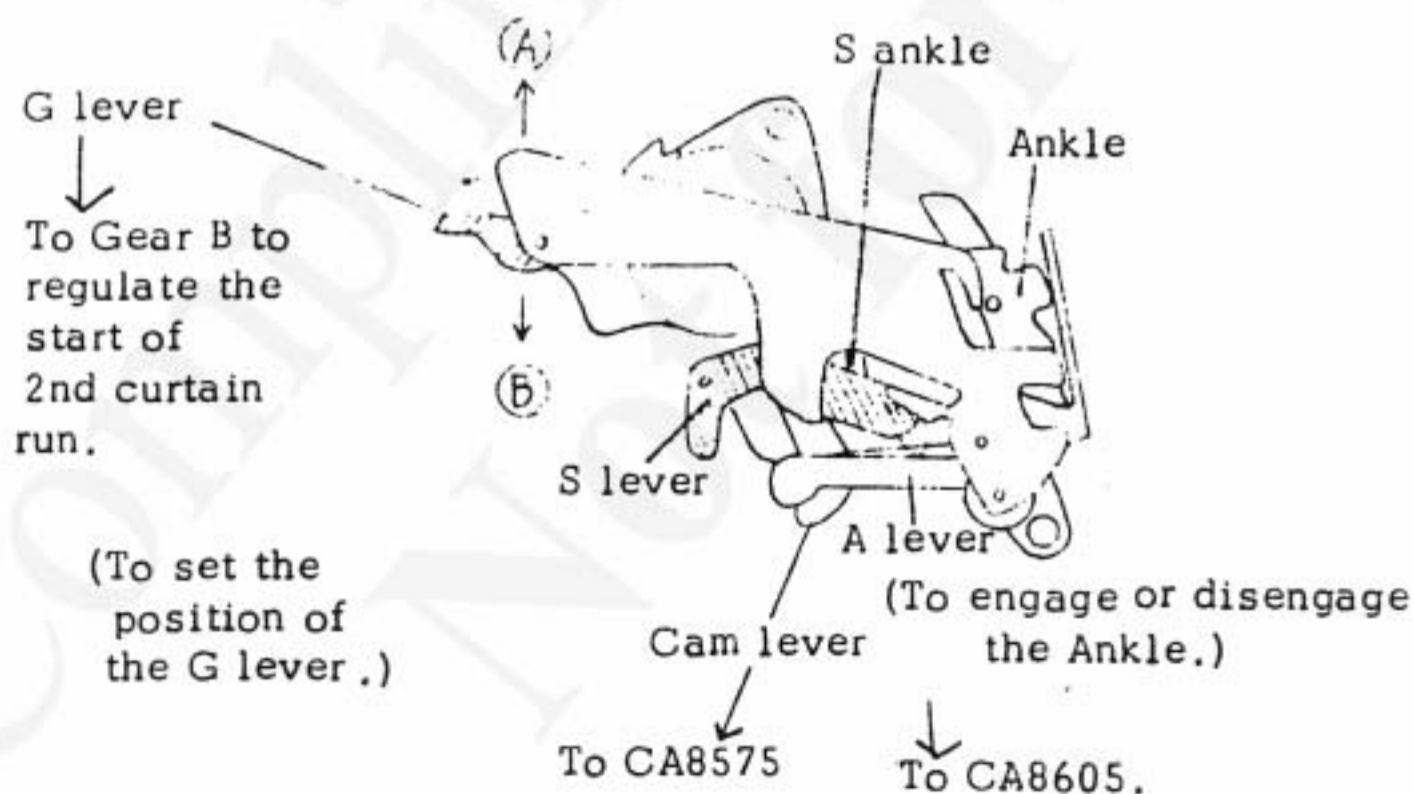
6. Improper timing at low shutter speeds:

If the speed at 1/30 - 1/1 sec. is in average longer (or shorter) than the proper timing, an adjustment is made by moving the governor. When it is longer, the governor is to be positioned rather towards the direction A, and when shorter towards B.
