OUTLINE OF REPAIRS

OUTLINE OF REPAIRSTABLE OF CONTENT

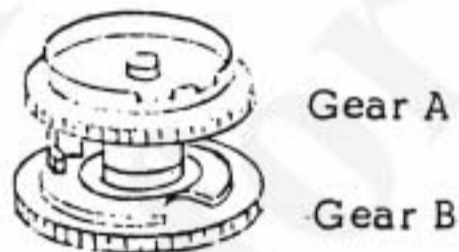
1) Adjustment of the curtain position.(Patch inclined.)

- (1) Turn 8519 (Shaft) to let 8592 (Claw) engage on to the Gear A and lock it. Do not directly touch the metal part of (8519) with fingers.
- (2) Remove 8857 (Shaft) on the lens side, turn 8521 (Stopper), lower 8520 (Shaft), and disengage 8520 from the Gear B.
- (3) Rotate the Gear B to bring its boss to the position coincident with that of the Gear A as shown below.

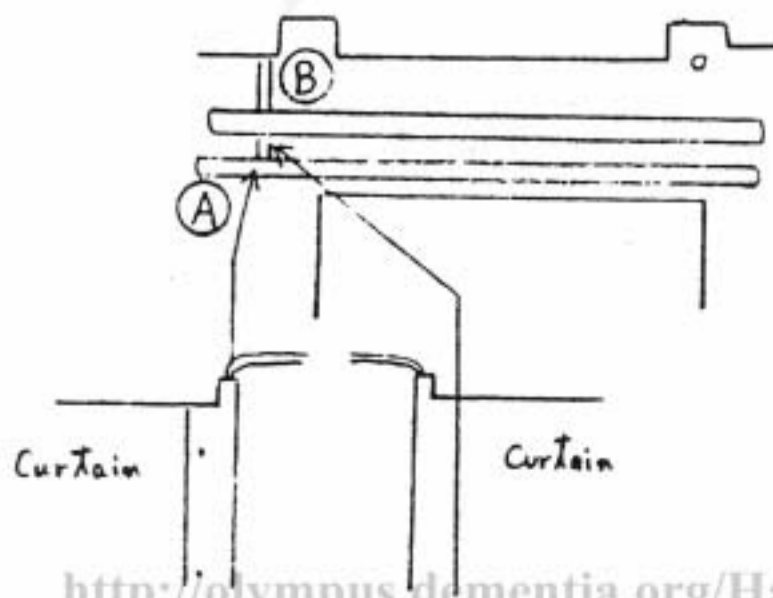
- (4) Do not change the position of the Gear B but turn 8520 until the Patch of 8600 (Curtain) reaches closest to the Scratched line (A) below) on the Die-cast Body. Then raise (8520) and let it engage onto the Gear B.

Tolerance: 0 - 0.3mm

Make fine adjustment on the alignment of the Patch of 8600 and the Scratched-Line on the die-cast by adjusting the 5 holes' positions.

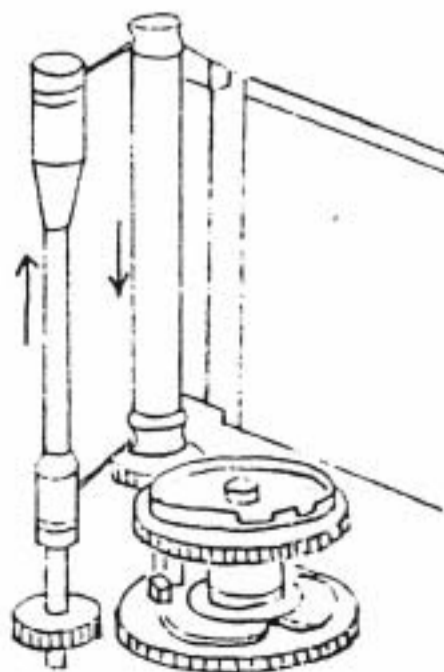
2) 1st curtain stops at the improper position.

After the shutter is released, when the boss of the Gear A is pressed against 8501 (Base Plate), the edge of 8538 (Curtain) should almost reach the Scratched-Line (see C below.)

If it does not, an adjustment may be made by moving vertically the mounting position of 8517 (Stopper) assembled in 8519 (Shaft).

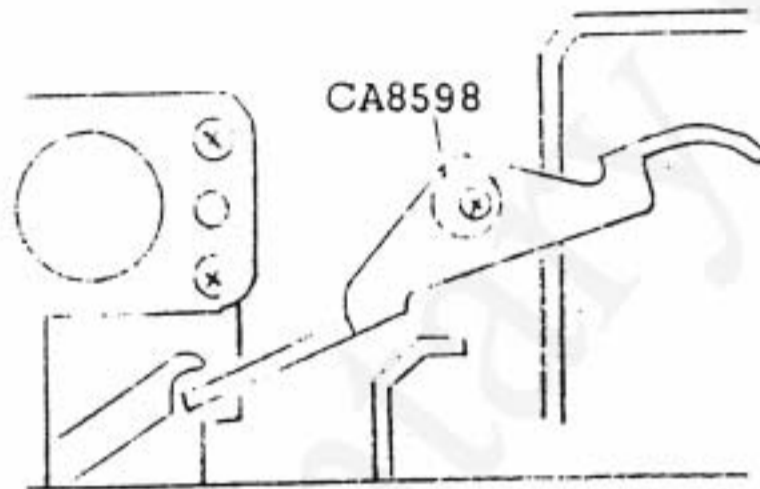
7) CA8595 (Lever) and CA8592 (Claw) stuck together.

8598 (Washer) is to be mounted in the manner shown below.

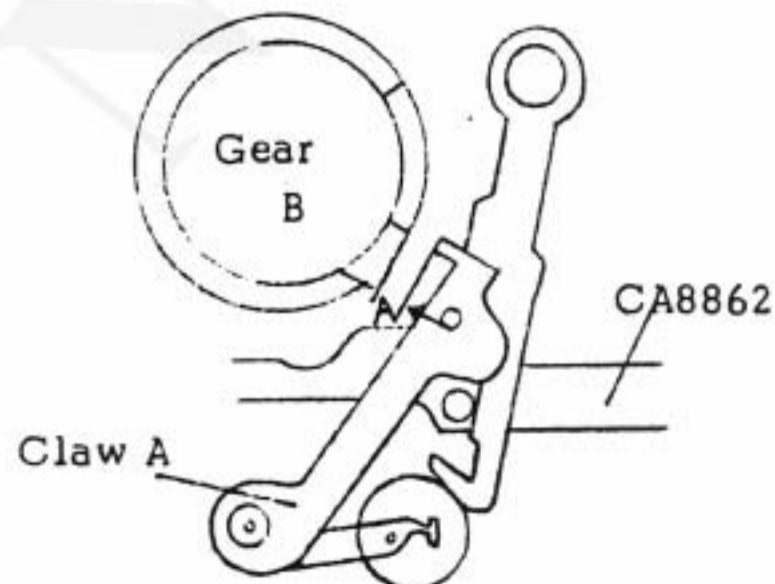
3. Adjustment of "B" shutter speed (Irregularity of B stop, immediate closing or remaining open)

(1) Upon completion of shutter charging, 8862 (Plate) should return to the original position accurately. At this time there should be a space between Claw A of 8567 (Shaft) and the Gear B of 0.5mm or above. (See below, the portion marked A) If there is not, an adjustment must be made by bending the portion marked with a circle in the picture below.

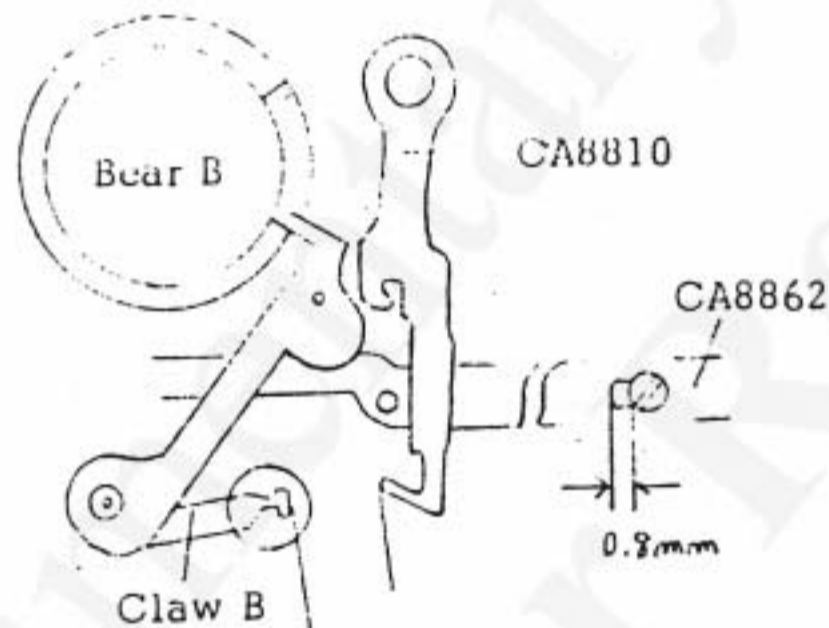
- (2) Press 9078, let Claw A of 8567 engage onto the Gear B, and see if there is a space of 0.2mm or above between 8810 (Plate) and Claw B when the space between the oblong hole of 8862 (Plate) and 8864 (Shaft) gets to 0.8mm. If there is not, an adjustment should be made by bending the portion marked with a circle in the picture below.

Upon such an adjustment, check the point (1) above, again.

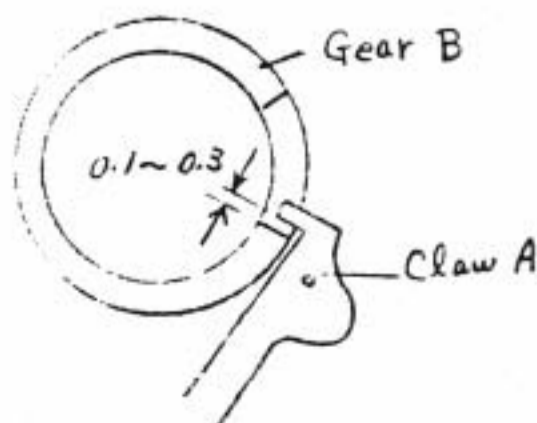
- 2) The space between Claw A and the Gear B.

Depending on the size of Claw A, there are three types of 8567 (Shaft). A proper selection should be made out of the three shown below, so that the space between Claw A and the Gear B would be 0.1-- 0.3 (as shown below).

An adjustment may be made by bending the tip of Claw A.

When Claw A is shaken if its lower edge hits the Gear B, an adjustment may be made by bending the Plate (B).

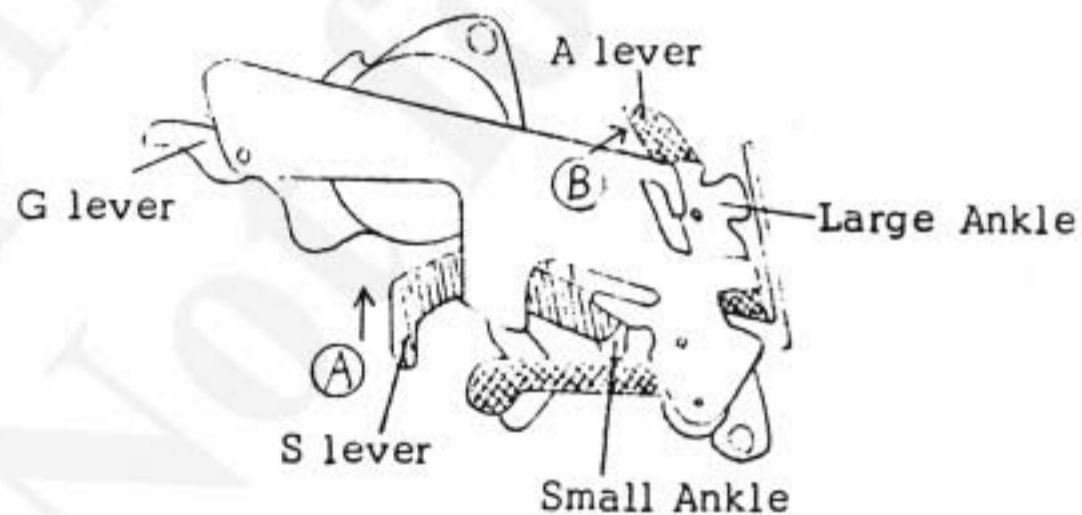
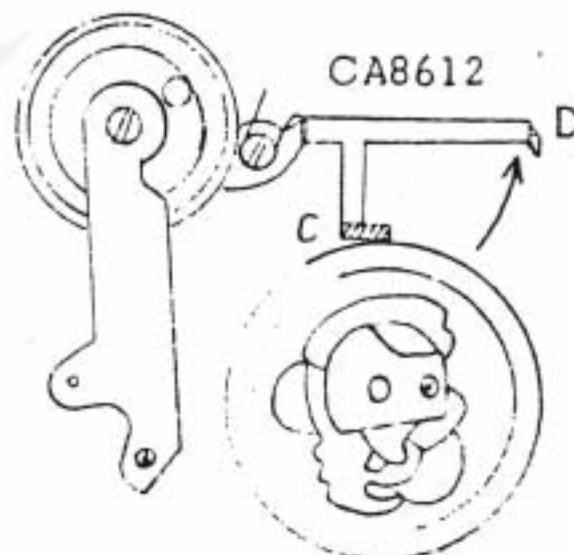
When 8575 is set at $1/1 - 1/8$, immediately prior to the shutter charging action 8612 starts working and portions A and B of the governor should move in the directions indicated by arrows to release the Large Ankle and Small Ankle of the governor.

Adjust by bending portions C and D of 8612 like that relative parts work as follows.

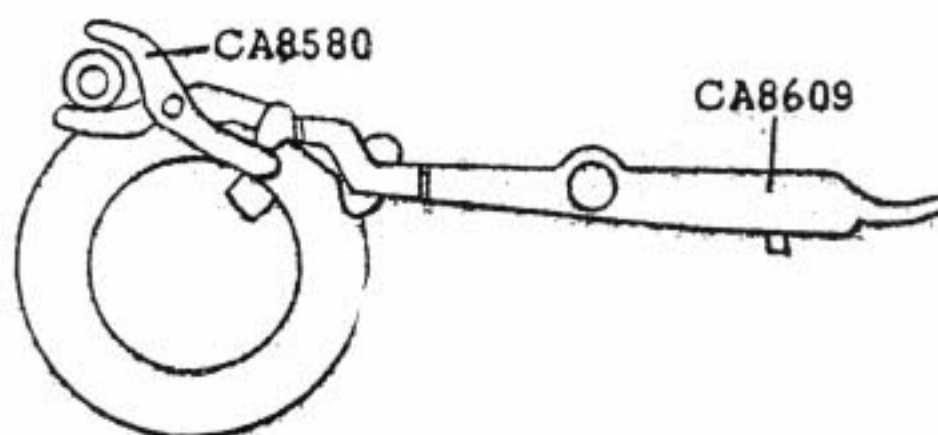
2) CA8580 lever rattling

Prior to film advancement, check the engagement between 8580 and 8609 by shaking vertically 8609. If such engagement is for less than $2/3$ the thickness of 8609, adjust the room at the rivet of 8580 to be within 0.3.

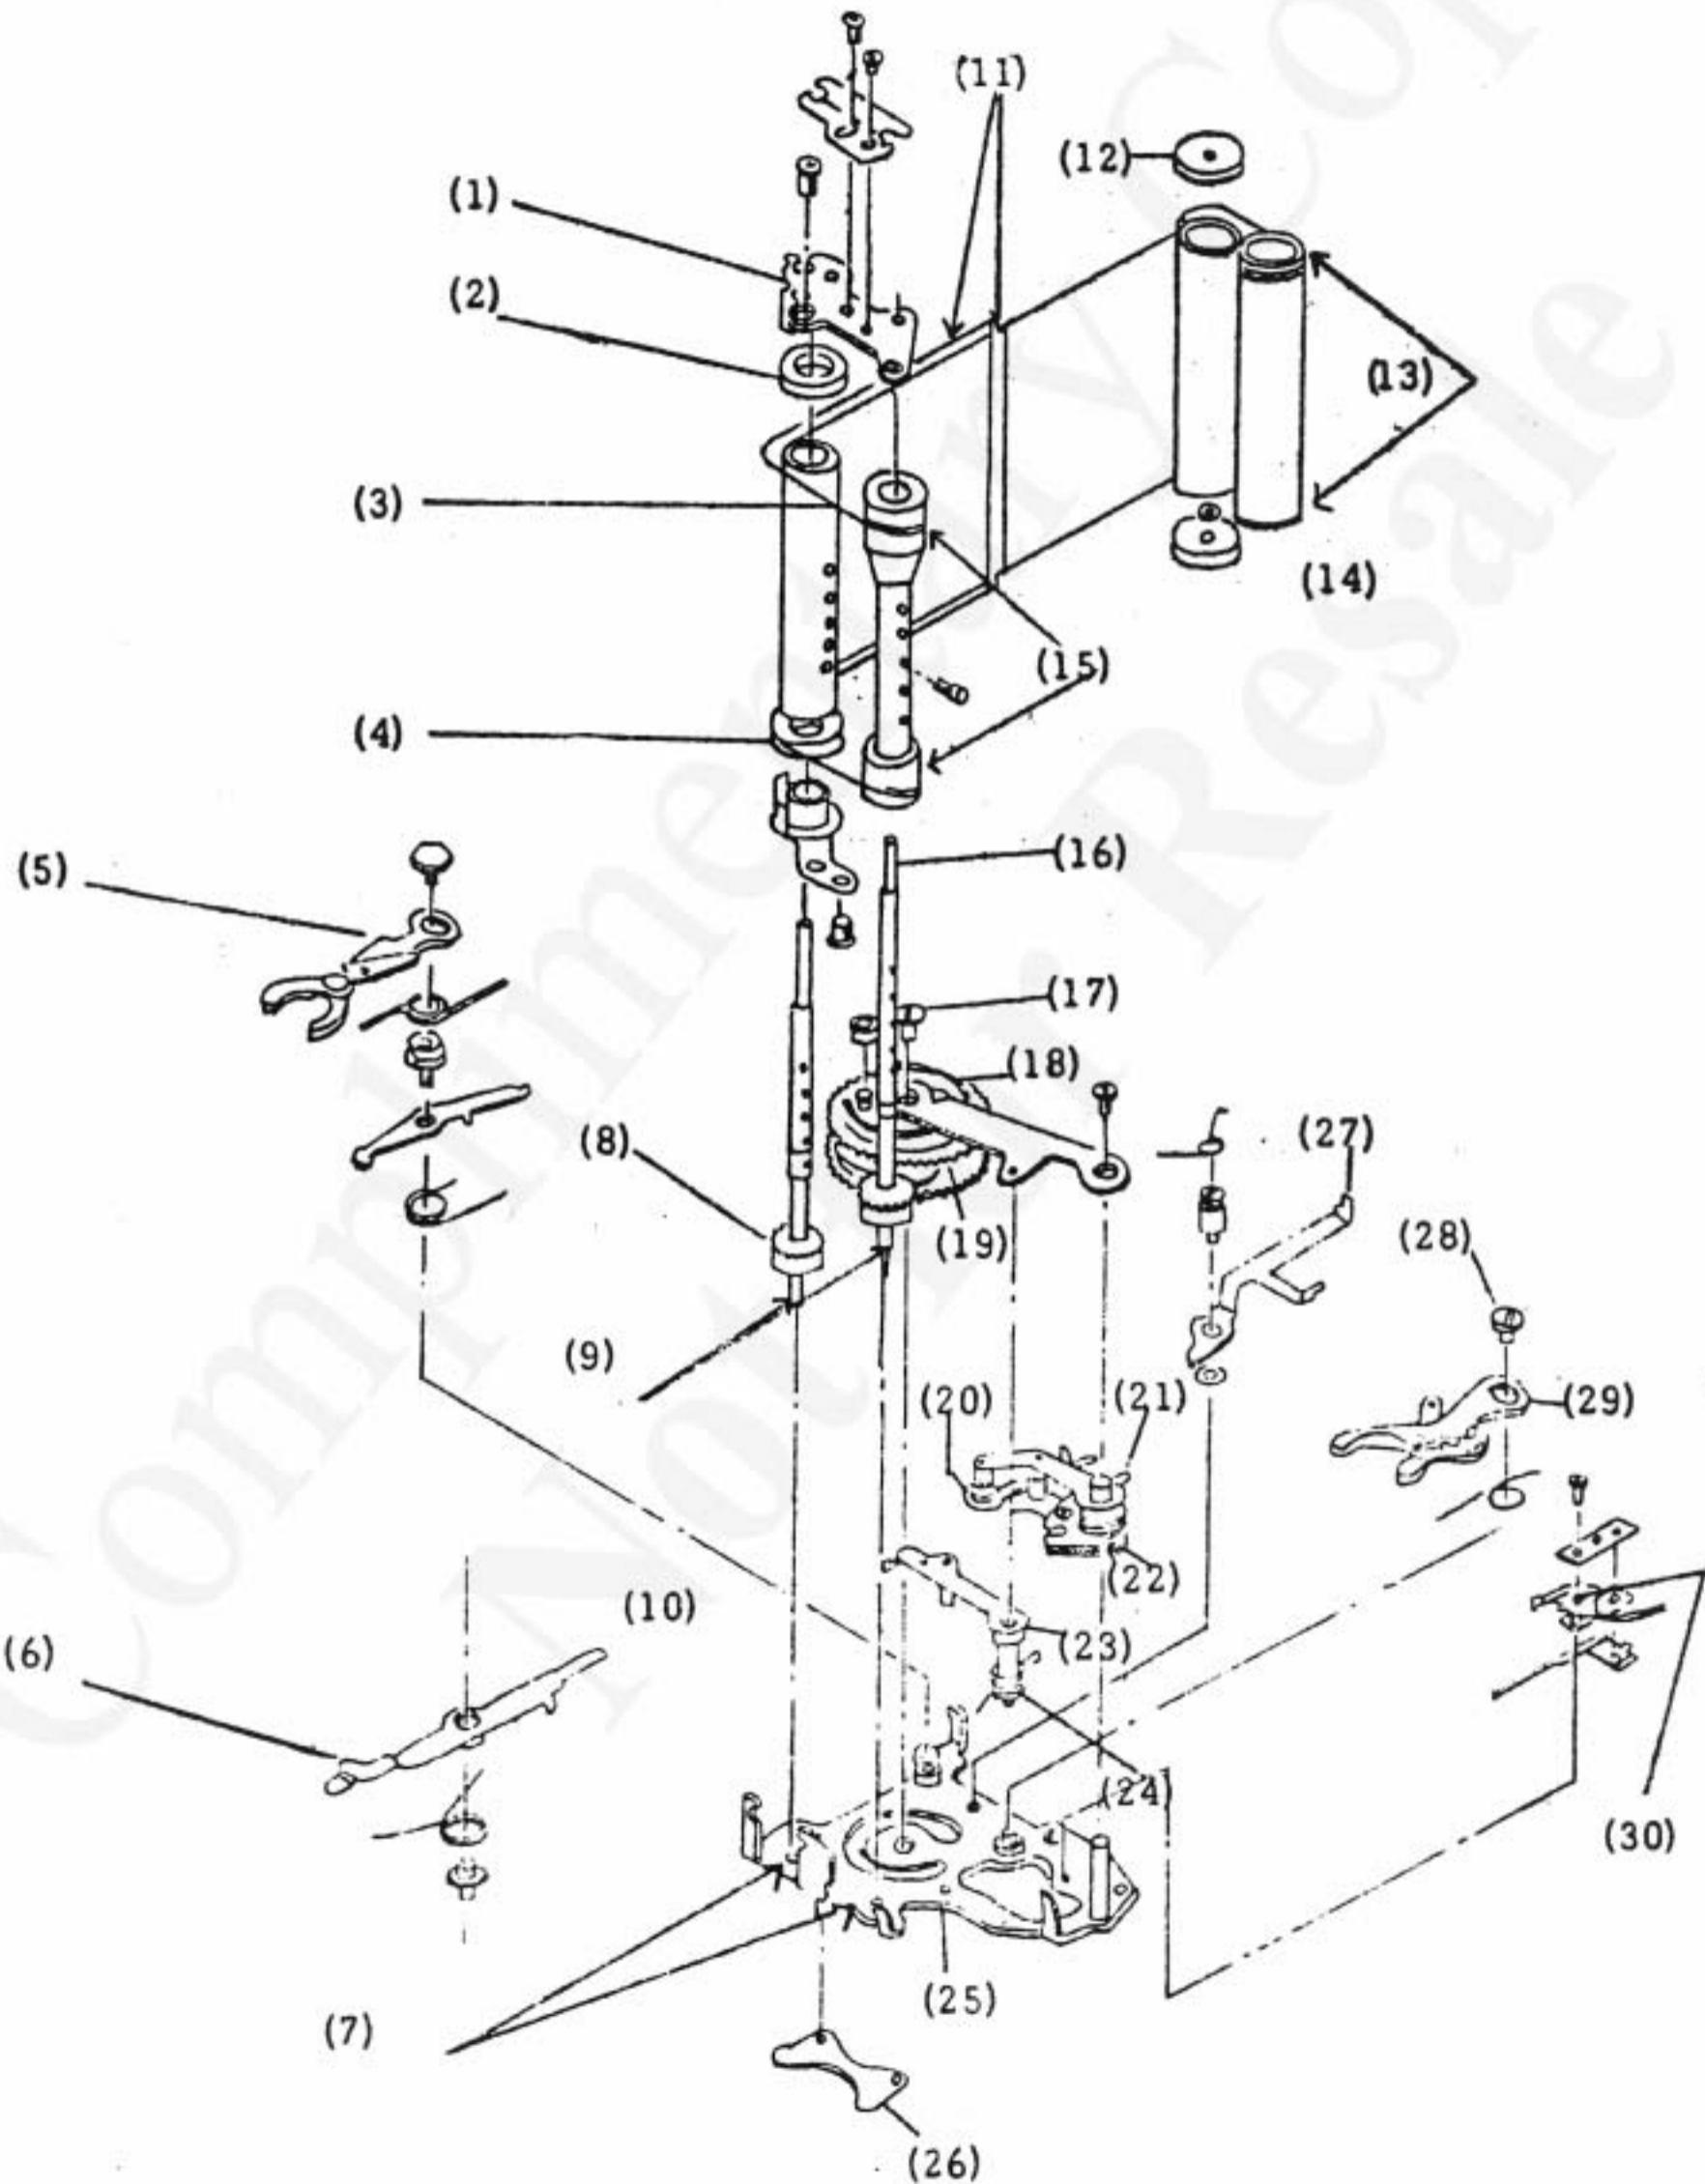
8. Irregularity in Curtain Speeds:

- (1) Mounting position of 8508.
- (2) Rotation of 8510. However, do not lubricate.
- (3) Whether 8537 (4 pieces) are off the roller.
- (4) Rotation of 8510. However, do not lubricate.

- (5) 8580. Check whether it with the Ring of the Shaft B.
- (6) 8609. Whether it is properly engaged on the lever.
- (7) 8501. Dirt or inaccuracy in surface finish at the guide holes for the Shaft A and B.

Check the following items and make necessary repairs or adjustments.

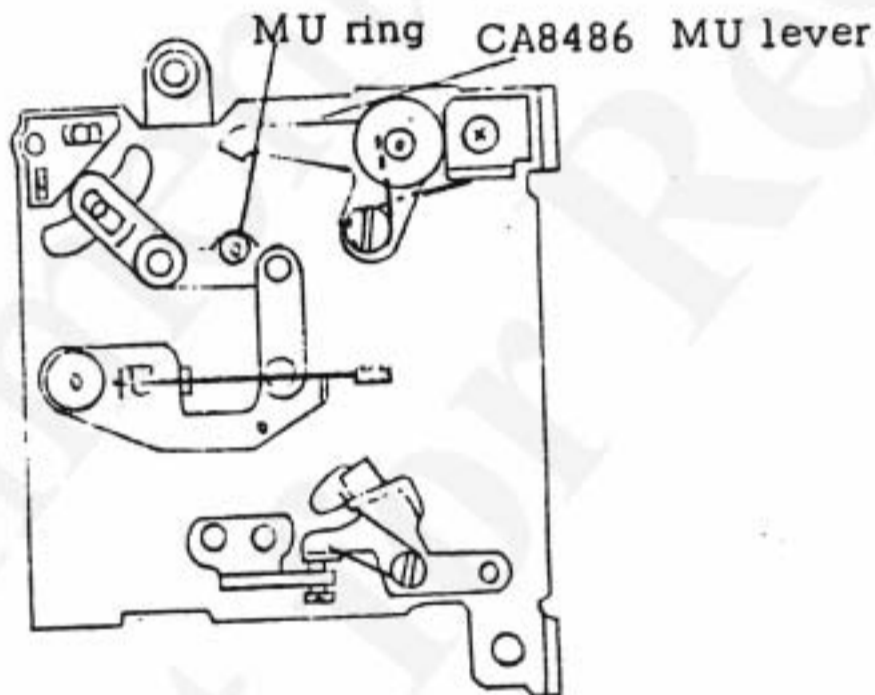
1) Improper selection of the MU ring

- (1) While the mirror is at the original lowered position, there should be a space of 0.2 or above between the tip of 8486 and the MU ring.
- (2) During the mirror-up operation, the mirror should be in such a position that its tip touches the damper and presses it accurately.
- (3) The MU knob should operate smoothly and should not get heavy toward the end of its motion.

Make a proper selection of the MU ring to satisfy the requirement cited in the Checkup column below.

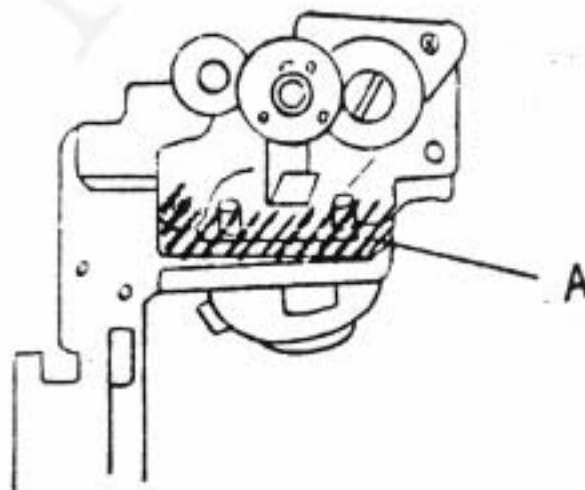
- 1) Filth or oil on CA9024 (Shaft)
Replace 9024.

- (1) Remove 9025 (Base) and 4073 and take out 9024 positioned at the low-luminosity. If it cannot be removed because of adherence by Araldite take off 8961. (However, avoid removal of 8961 as much as possible.)
- (2) Clean the following parts with the ether alcohol and apply the oil Oilproof Liquid: 9025, around the area where 9024 is mounted, 8977 (Plate), and 9142.
- (3) Apply a little Araldite in the hole where the A fits in 9025 and set 9024

To be cleaned and applied with Oilproof Liquid.

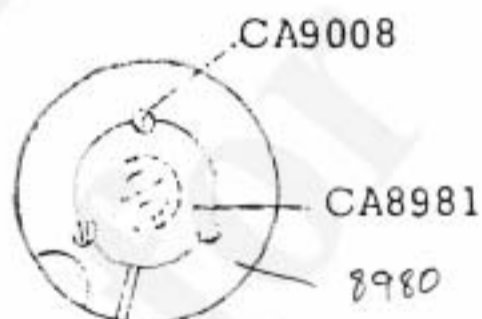
If the zero point is extremely out of position, adjust the position of 8981.

- (1) In case of + (an excessive swing), loosen 9008 and turn 8981 to the right.
- (2) In case of - (an insufficient swing), turn it to the left. Upon adjustment, turn the shutter dial to adjust the loosened string.

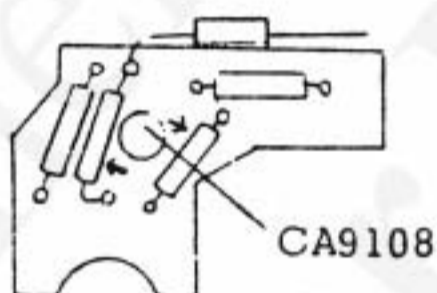
- o Is the resistor soldered onto the printed board as tightly as possible?
- o Isn't the resistor in contact with 9108?
- o Is the printed board fixed closer toward the surface of the rails on the camera body?

Check the following points and make necessary repairs or adjustments:

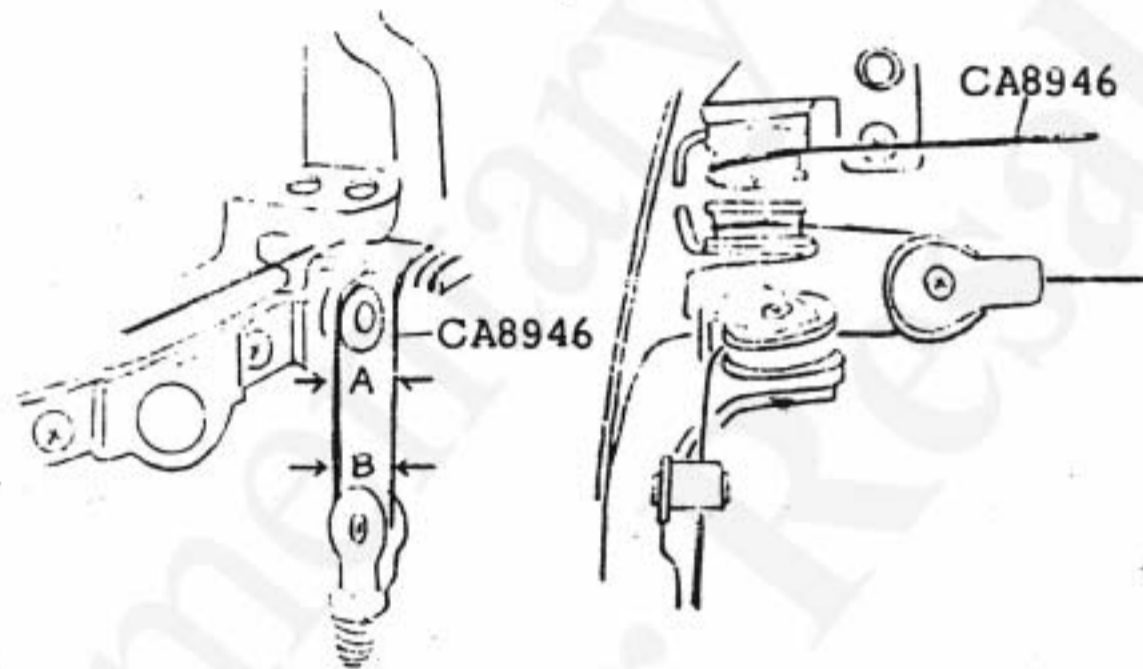
2) Adjustment of CA8946 (String) (dislocation and entanglement)

- o The string should not be dislocated from the pulley.
- o The width at A and B should be approximately the same.
- o When 8879 is turned until it hits the Cam Roller, there should be a space of less 1 mm between pulleys of the B spring and the B spring plate.

8946 is to be threaded as follows:

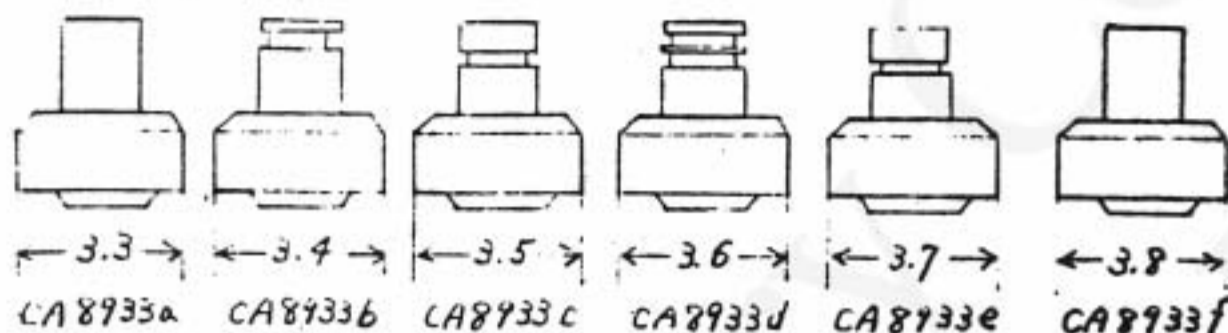
3) Improper selection of CA8933 (Roller) (diameter)

8933 should turn smoothly and accurately without an extreme difficulty such as stoppage and uneven movement.

Referring to the checkup column on the right, make a proper selection and check the operation.

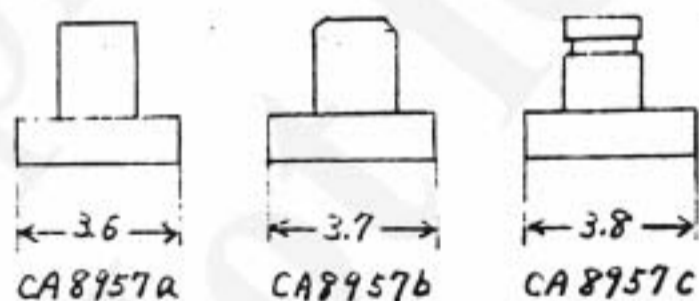
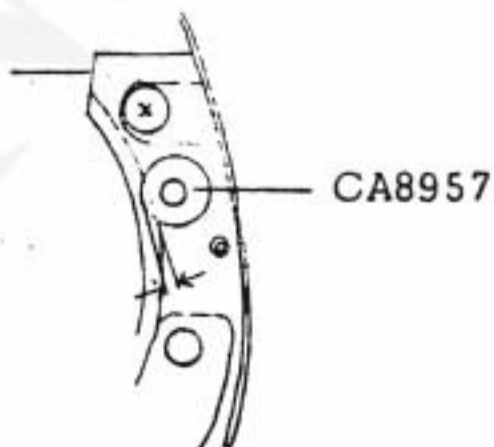
4) Improper diameter of CA8957 (Roller)

A little space may be permissible between 8957 and 8879. (If the roller selection is made allowing no space between them, it sometimes causes poor returns of 8879.)

8957 comes in three types. Referring to the checkup column make a proper selection and check the operation.

Do not touch 8957 directly with bare fingers.

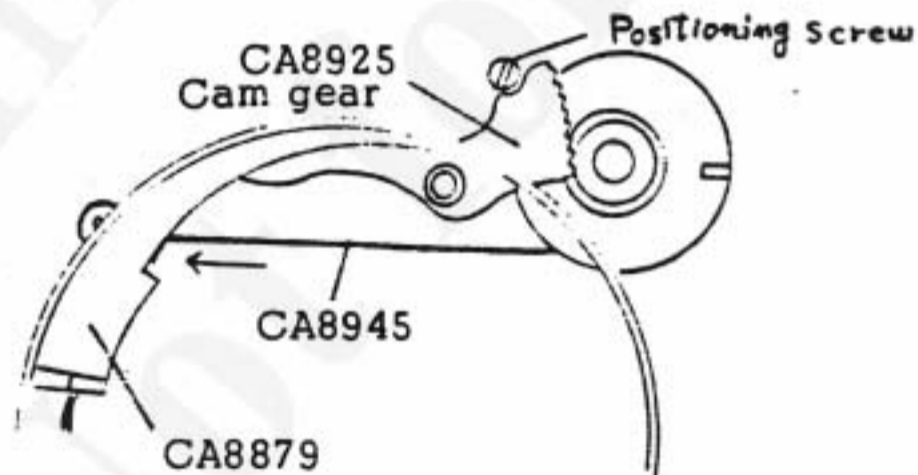
4. Improper Adjustment of the Cam gear positioning screw:

- o Upon adjustment, there should be a space between the A and the stopper pulley.
- o When 8879 is turned to its fullest extent, the A should not hit 8925.

When 8945 is pulled fully toward the arrowed direction, the space between 8879 and 8925 should be with 0.3mm. An adjustment should be made to fulfill this requirement by the Positioning screw.

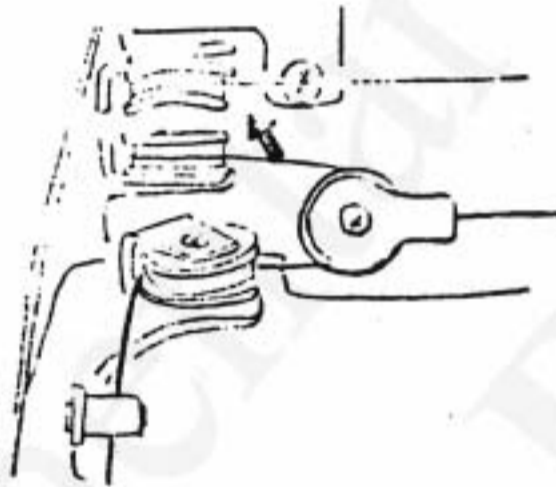
- o If the meter is not mounted onto the Front Die-Casting, attach a 12 gr. weight at the tip of the string and check the operation.
- o Each pulley is to turn smoothly and accurately.
- o Tolerance on the dial gear should be 0.1 or less.
- o When the dial gear is rotates, 8924 should not move.

8944 (the string for the dial gear) should be threaded as follows. When threading, it should be started from the arrowed direction to avoid crossing with the String.

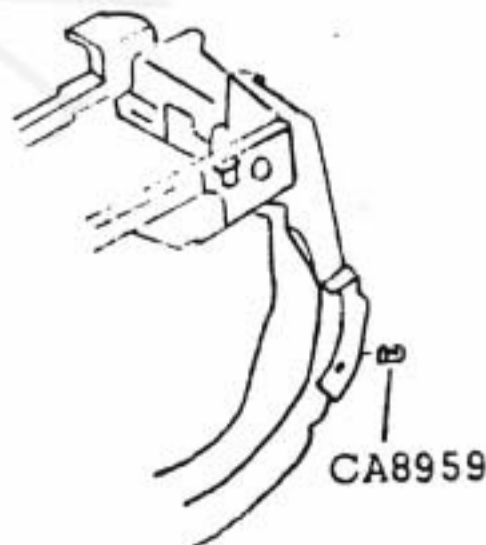
2) Tolerance adjustment on the dial gear (8880)

An adjustment is made with 8959 to bring the tolerance on 8880 to 0.1 or less.

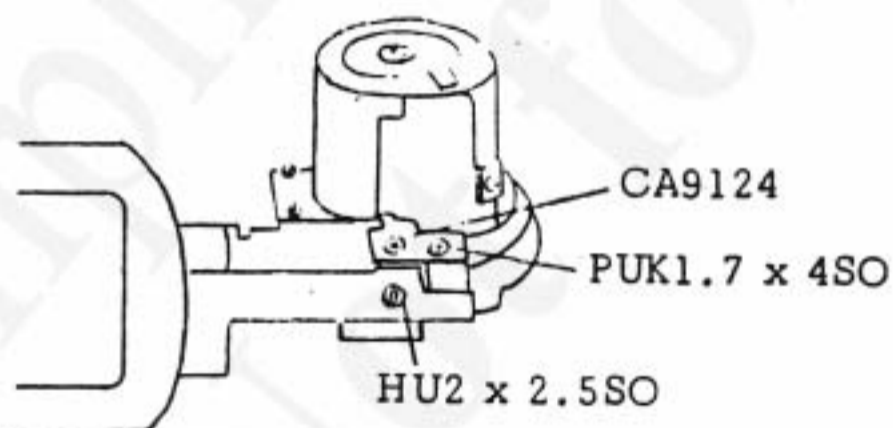
- o Place the mercury battery in the camera and turn off the main switch.
- o With ASA 100 at the shutter speed B, the aperture ring is gradually turned from F16 toward open. At this time, the meter needle should once jump to + 2.0EV above the index center before it stays at - 0.5EV. (See Fig. A)

1) Adjustment of the L contact point position

Ref. Checkup column. Loosen two PUK1.7 x 4SO on 9124. Slightly move HU2 x 2.5SO forward or backward for adjustment.

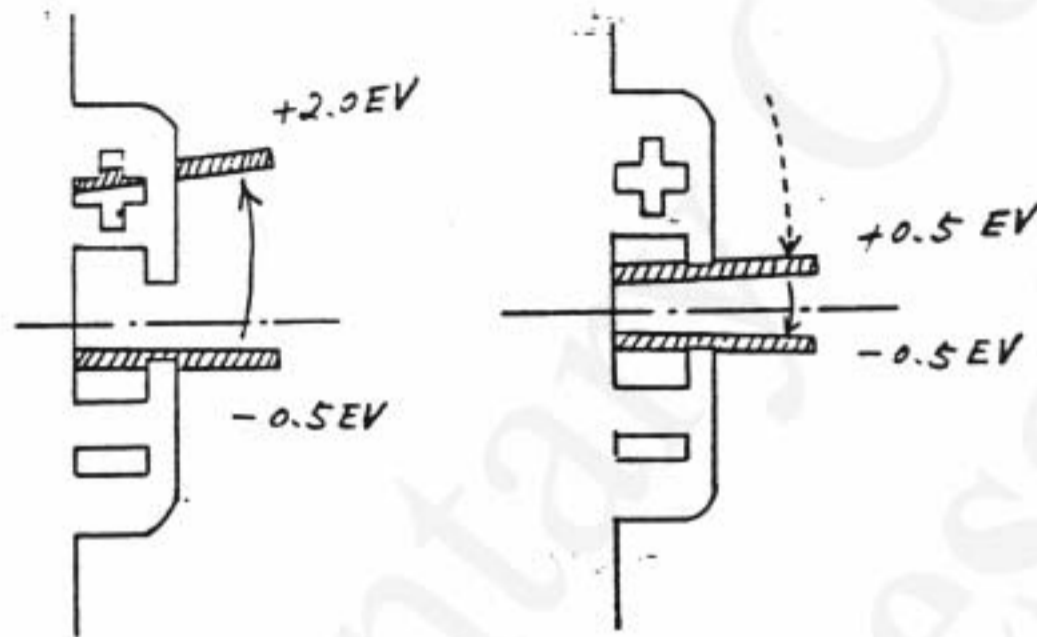
- o At this time, the aperture should be slightly stepped down than F2.8.

- o When the lens aperture is stepped down from the wide open state, the meter needle should once swing down to a position lower than -0.5EV before it is stabilized at +0.5EV. (See Fig. B.)

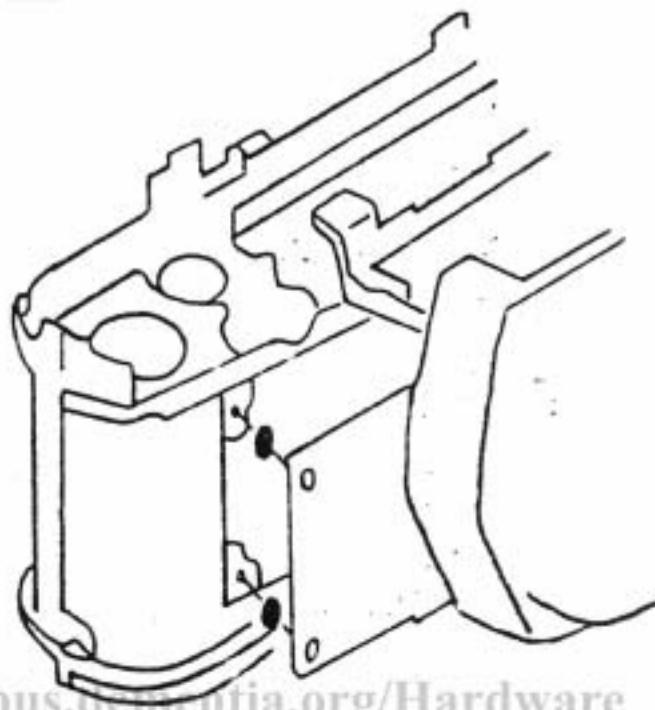
KC-0070G #01 Olympus M Mount U and KC-0070G #3 46.00 gauge are to be used to measure the four points on the rails.

Parallelism (the difference between measured points) should be less than 0.02.
